U. S. ARMY BOARD FOR AVIATION ACCIDENT RESEARCH • FORT RUCKER, ALABAMA

CH-37 ACCIDENT SUMMARY

1 July 1957 through 30 November 1966

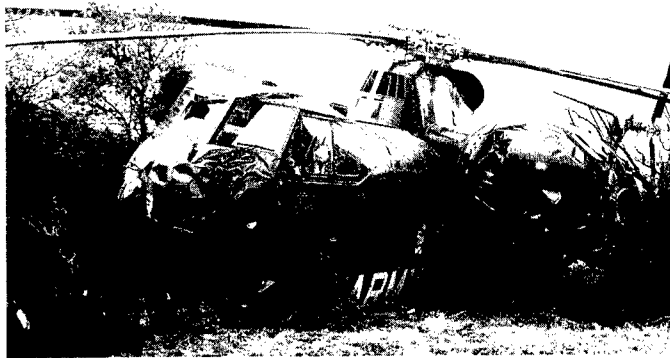
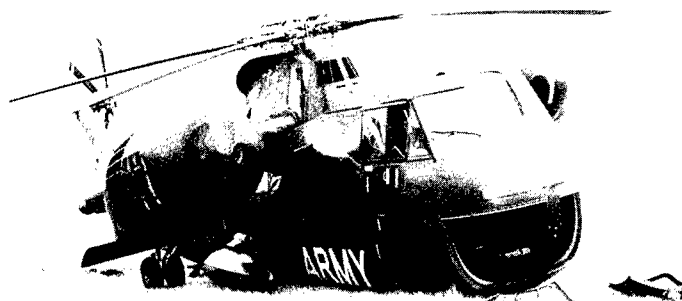
04603

04603—Helicopter lost altitude abruptly, following maximum performance takeoff, and settled into trees. Major damage to main rotor blades, tail rotor blades, landing gear, clamshell doors, engine and nacelles and fuselage. CAUSE: Shifting, gusty wind and downdraft, which the pilot did not anticipate prior to takeoff.

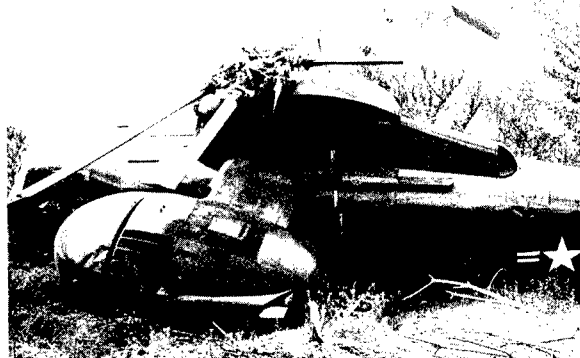
04318

04318—Right main gear hit soft spot in sod, digging in approximately one foot. Aircraft moved forward and came to rest on right auxiliary tank and right bottom side of fuselage. CAUSE: Landing gear down lock pin sheared during running landing due to soft spot.

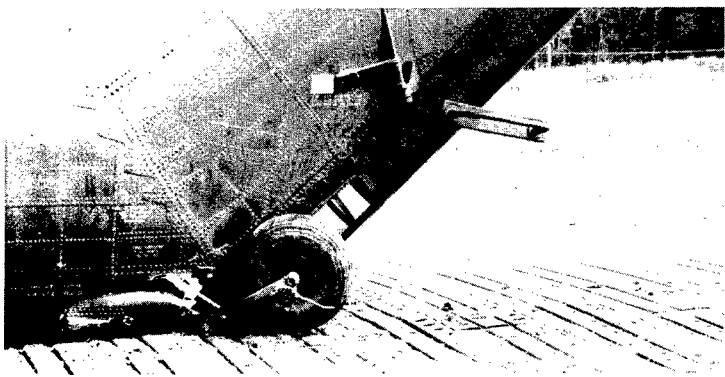
00578

00578—During a practice demonstration, the helicopter landed and the pilot was instructed to take off again. At approximately 50 feet, the helicopter began to lose altitude. The main rotor blades struck a tree 240 feet from the point of takeoff. One fatality and two injuries resulted. CAUSES: (1) Pilot was

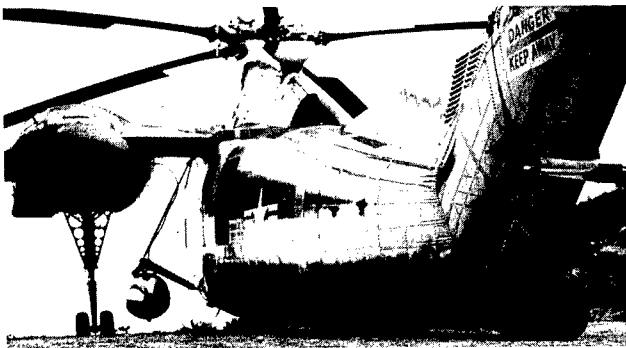
A117

A117—After takeoff, the No. 1 engine began to lose power. The helicopter failed to develop sufficient airspeed and altitude to clear wires across the flight path. Pilot attempted to abort takeoff and land. Helicopter settled through the wires and struck a curb, causing major damage to the tail wheel and pylon section. CAUSES: Engines failed to develop sufficient power for takeoff due to prolonged operation at ground idle which resulted in fouled plugs. Pilot selected takeoff flight path obstructed by wires and parked automobiles.

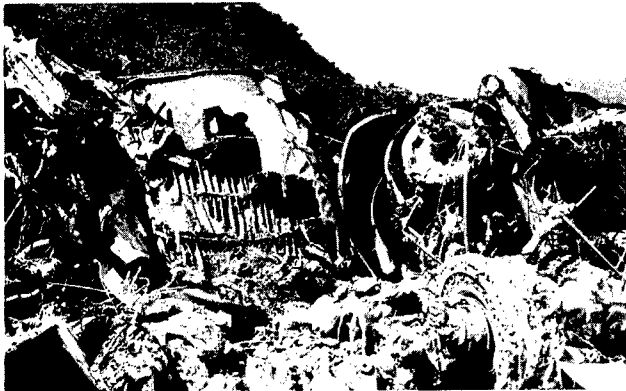
06742

06742—Helicopter flew into downdraft 15 feet above and 25 feet short of the desired touchdown spot during approach to mountain helipad. The pilot applied power and stopped the sink rate, but the tail wheel strut hit the edge of the concrete helipad. The helicopter continued forward and the tail wheel strut assembly was pulled loose from its attaching point. CAUSE: Failure to evaluate wind in the vicinity of the helipad.
